BUS ACOUSTIC PERFORMANCES OPTIMIZATION

Renan PHILIPPE^{a)}, Fabrice CARTA^{b)}, Laurent BLEANDONU

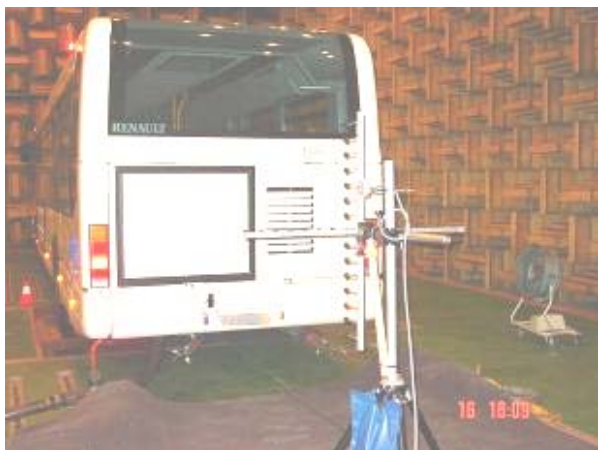
Figure 1. Acoustic antenna measurement in semi-anechoic-room.

A microphone array in near field was also used on certain external parts of the bus (bridge, exhaust system), in order to be able to quantify and classify the importance of the acoustic power of these

parts. This technique uses a smaller antenna : the system developed by MicrodB with its SuividB software under OROS system was used for this study. In semi near field situation, it allows for the calculation of acoustic pressure and an estimation of the acoustic power.

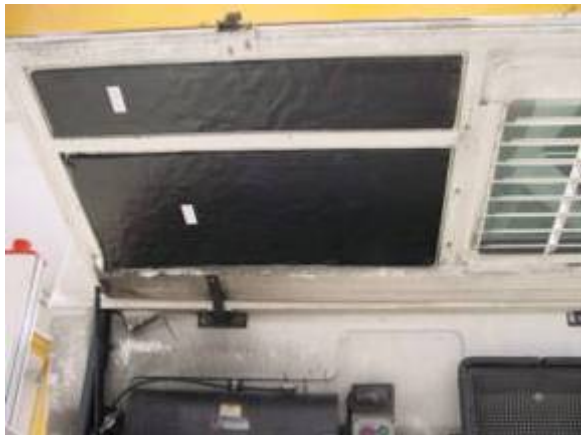
Figure 5. SILENT CUSHION fitted on backside panel.

- To develop a new waterproof sound absorption system called SILENT CUSHION, in conformity with the customer specifications, notably with regard to waterproofing peeling and tearing.
- To develop and reinforce the soundproofing solutions near the principal sources,
- To modify exhaust system components.

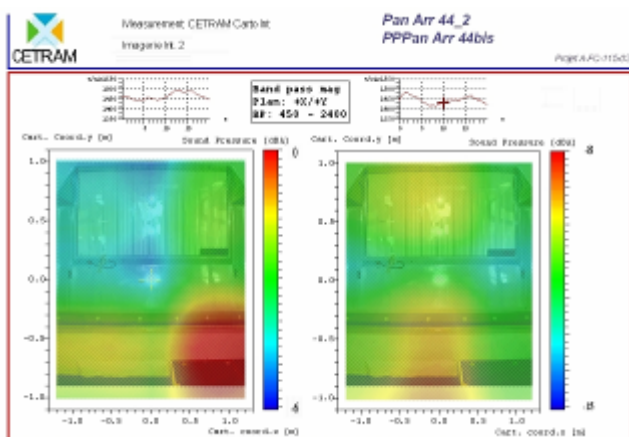
Figure 6. Acoustic cartography of the backside, before and after and after treatment at 1450 rpm.

The best laboratory-developed solutions were prototyped and fitted to the vehicle. Prototyping included the backside of the bus which was changed as well as many areas located on the back part of the vehicle, where principal sources were situated. The areas which were initially the noisiest were then evaluated after treatment through an acoustic cartography technique under conditions defined in initial specifications. To facilitate the implementation, after treatment for external noise, the cartographies were measured in static condition. The solutions proposed were prioritized (3 for the cockpit area, 2 for the engine compartment) based on the cartography calculated when comparing the levels obtained.
